Manhole Inspection Summary

Manhole # S1900_026MH

Insp Date: **7/5/07 10:32 AM**

Location Address: **2004 BRYANT-WHITTIER**

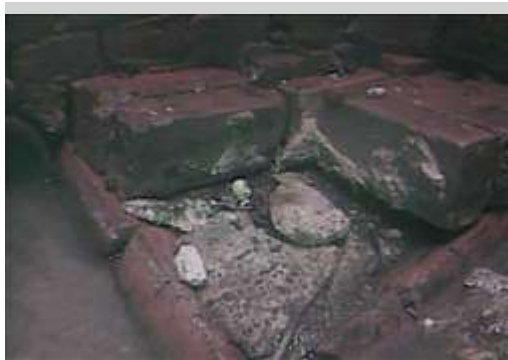
Defect 5

Condition: ☐ Sound ☐ Cracked ☐ Root Intrusion ☒ **Deteriorated** ☐ Leaks ☐ Debris

DETERIORATION OF BENCH AND
DEBRIS

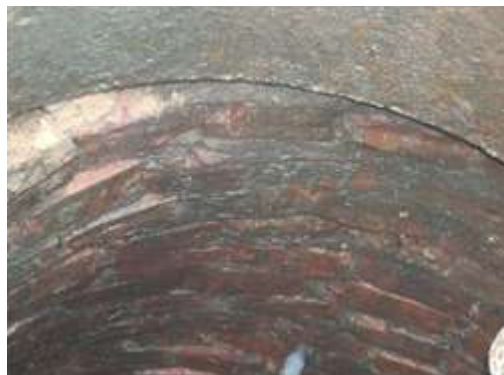
Defect 4

Infiltration: ☐ None ☐ Joint ☐ Cracks ☐ Mortar ☐ Roots ☒ **Wall**

INFILTRATION OF CHIMNEY

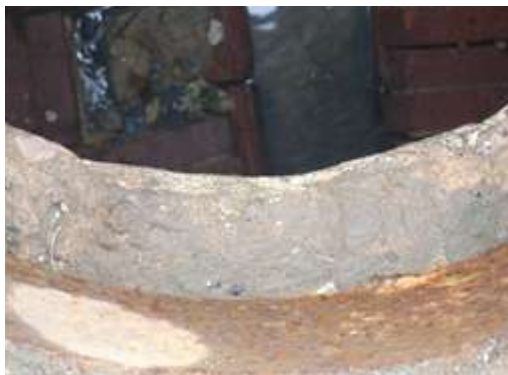
Defect 3

Offset: **5** (in.)

FRAME OFFSET

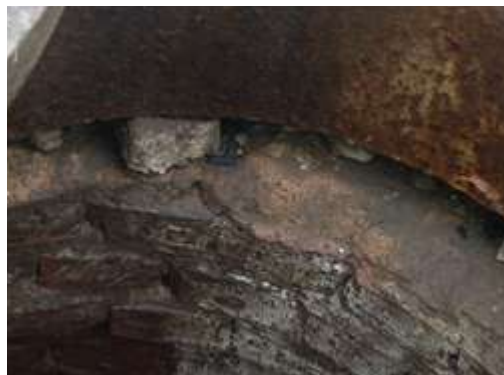
Defect 2

Condition: ☐ Sound ☐ Cracked ☐ Root Intrusion ☐ Loose Brick ☒ **Deteriorated**

DETERIORATION OF CHIMNEY

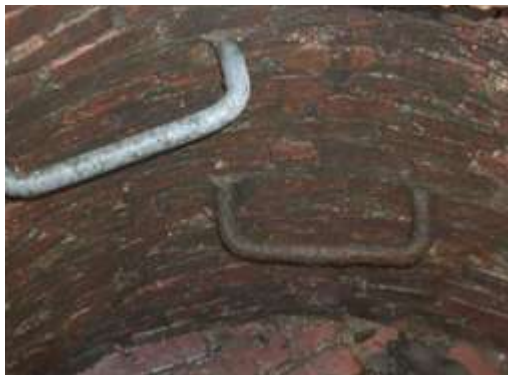
Defect 1

Count: **3** Missing: **0** ☒ **Corroded**

CORRODED STEP

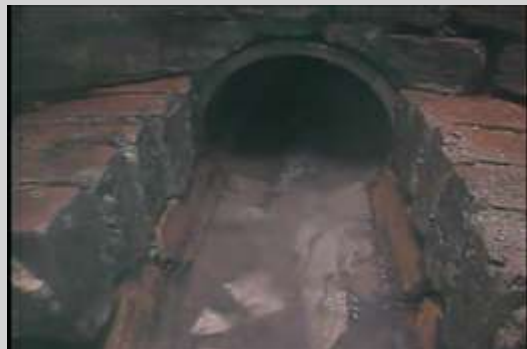
8 O'Clock Inflow

Deposits: ☐ None ☐ Mud ☐ Sludge ☒ **Debris** ☐ Grease

Silt Depth: **2** (in.) Deposits Extent: **Light**
